NASA
Reference
Publication
1161

Evaluation of Multilayer
Printed Wiring Boards by
Metallographic Techniques

*An Illustrated Guide to the
Preparation and Inspection
of Plated-Through Hole
Test Coupons Based on the
Requirements of MIL-P-55110D*

*Goddard Space Flight Center
Greenbelt, Maryland*

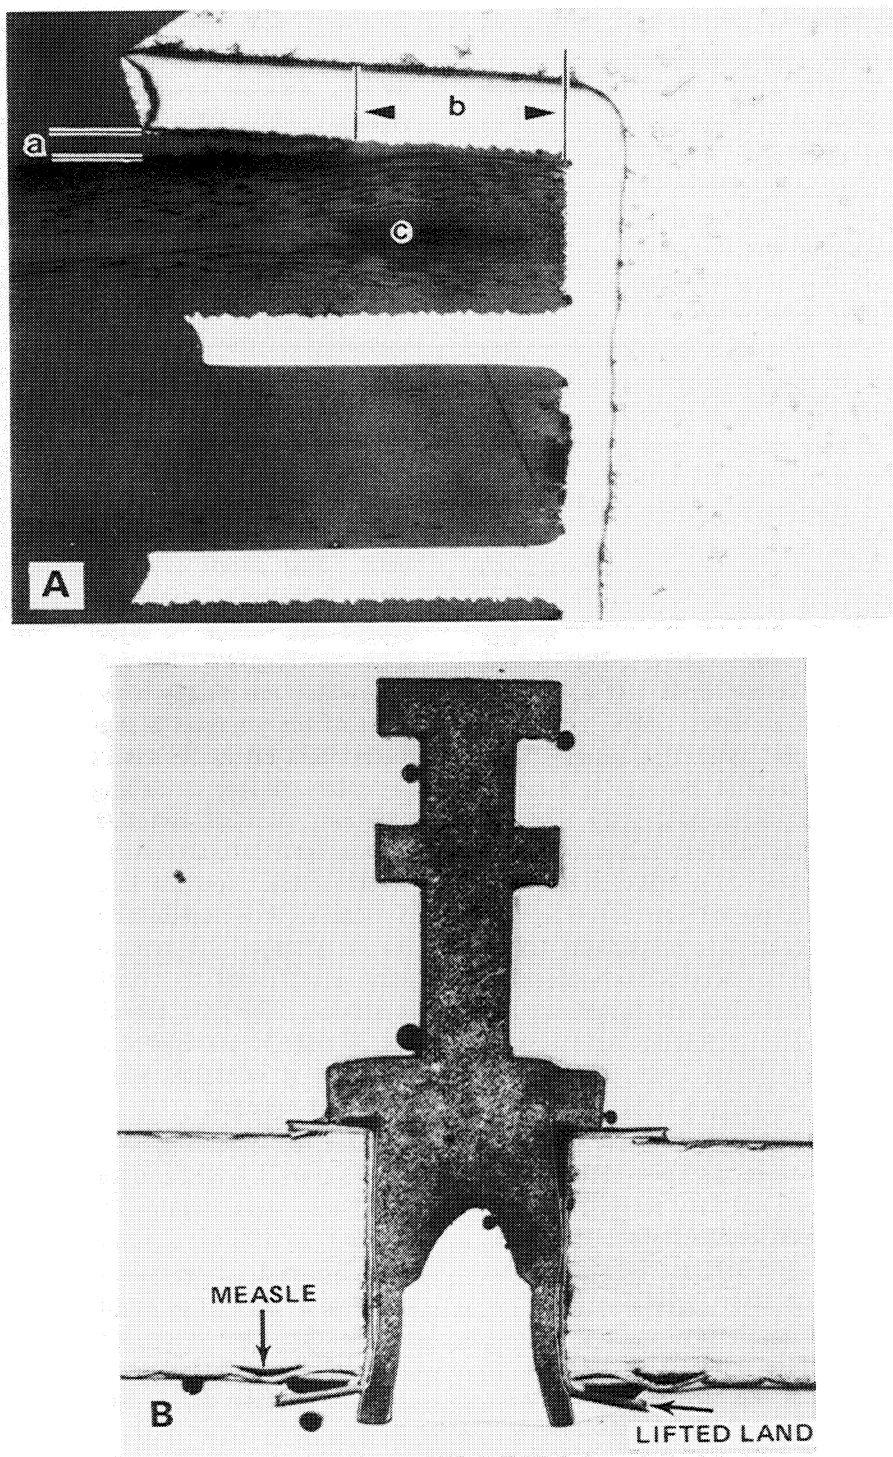
Figure 30. Lifted lands after thermal stress.

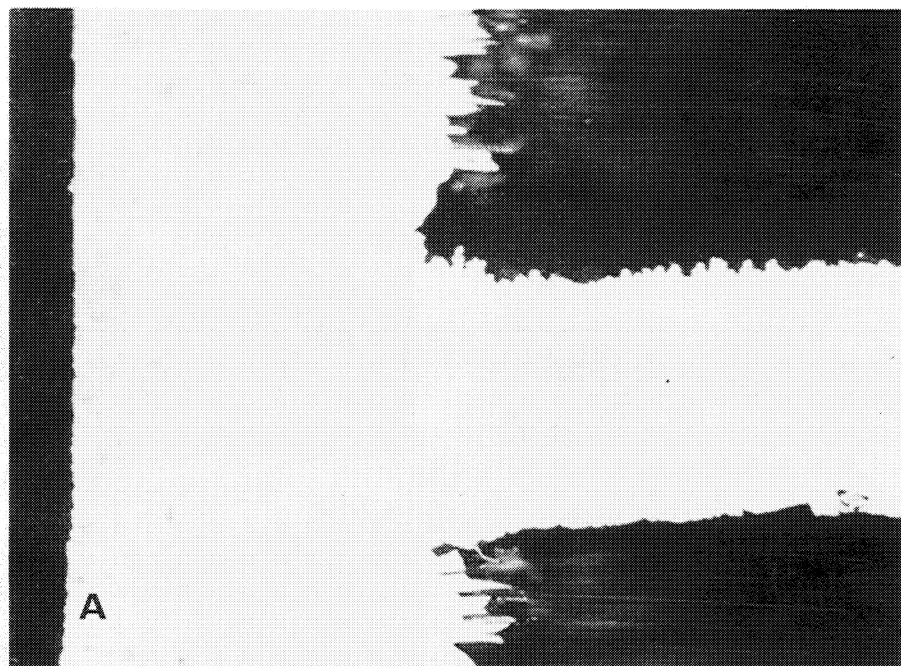
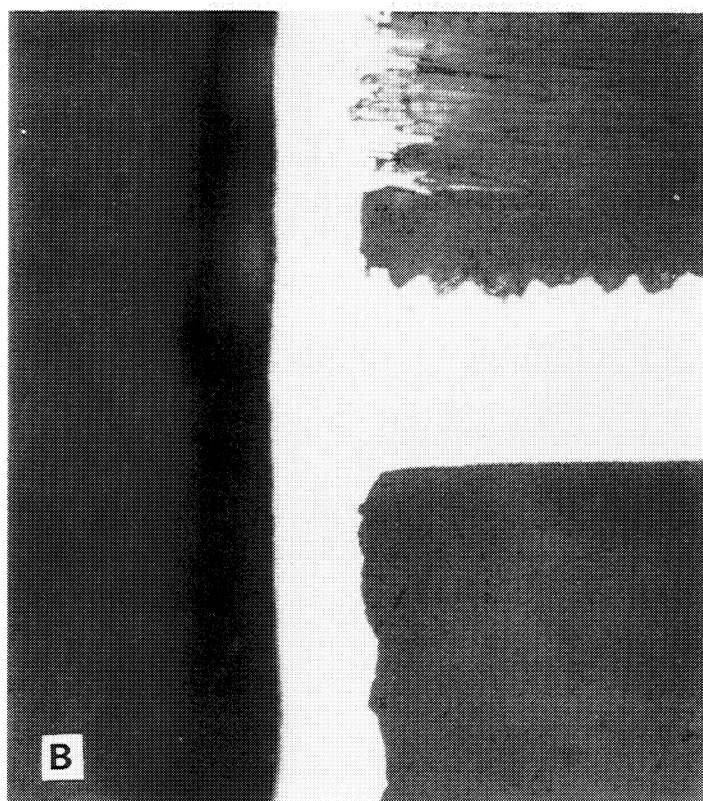
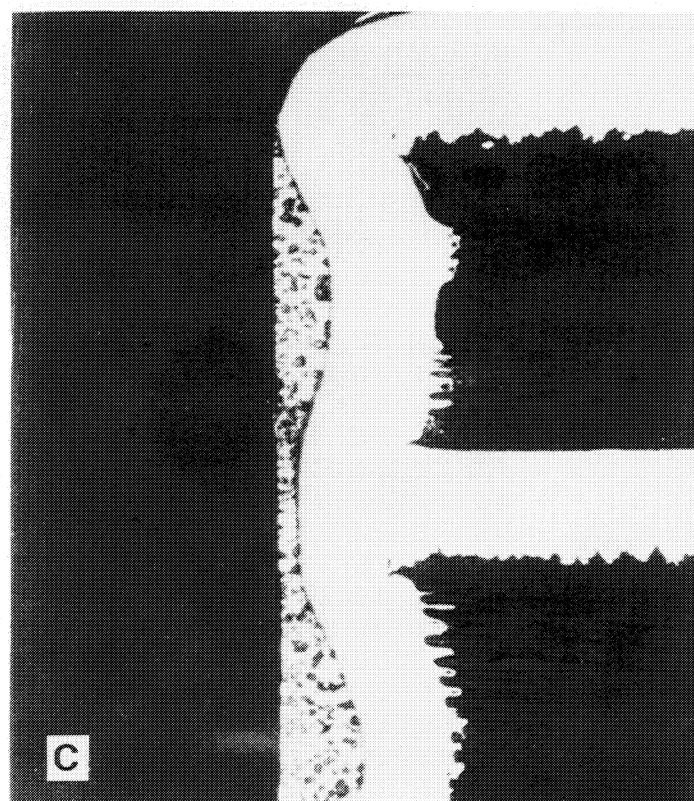
Figure 34. Visible demarcation lines at barrel/innerplane junctions ("fine line" defects) seen prior to etching. Coupons were not solder float tested. A – 500X; B – 400X; C – 200X.

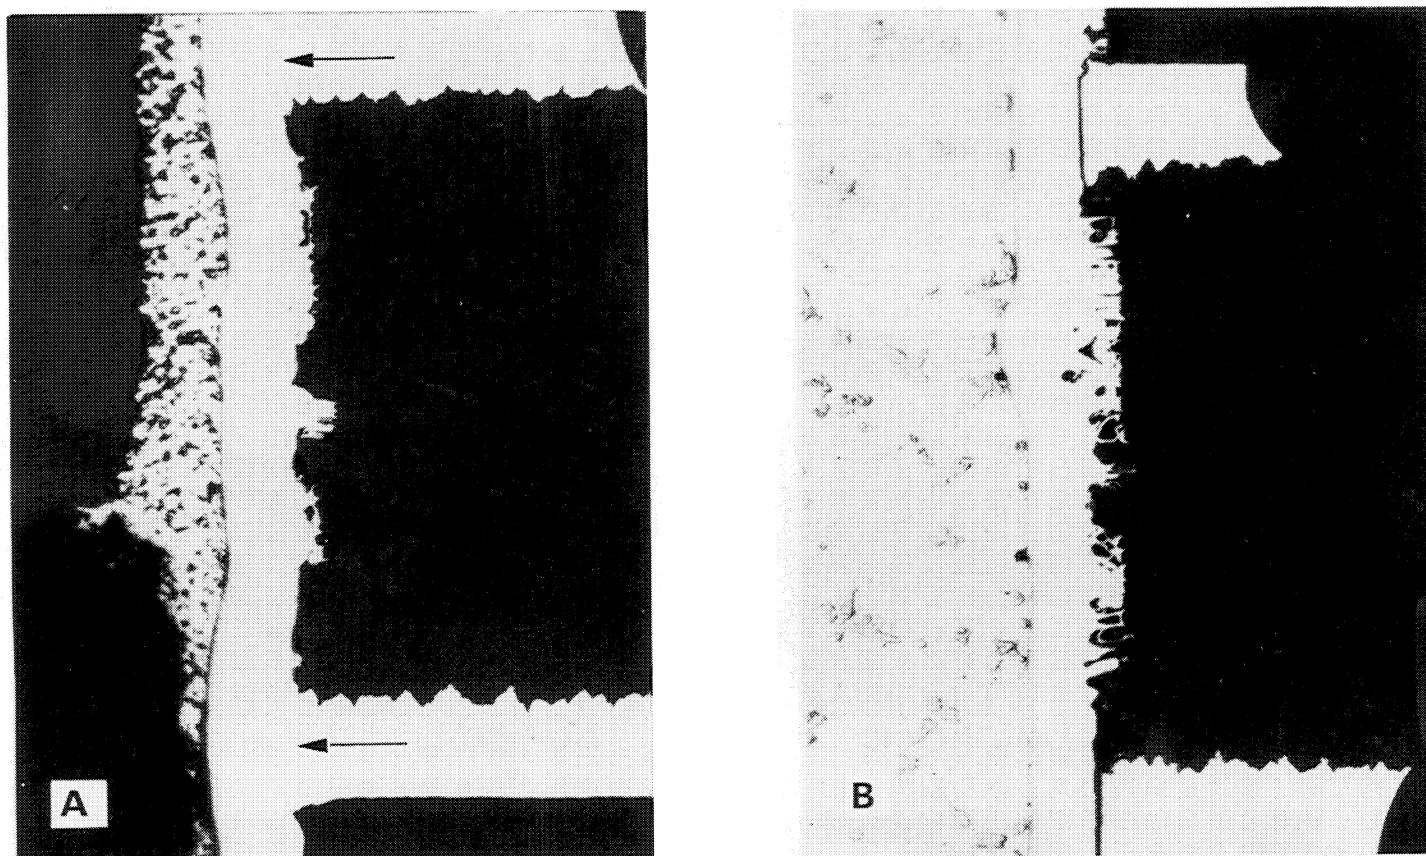
Figure 35. Coupons which exhibit fine line defects before solder float testing may show separations after thermal stress.

A. Continuous fine line defects before solder float. Unetched, 200X.

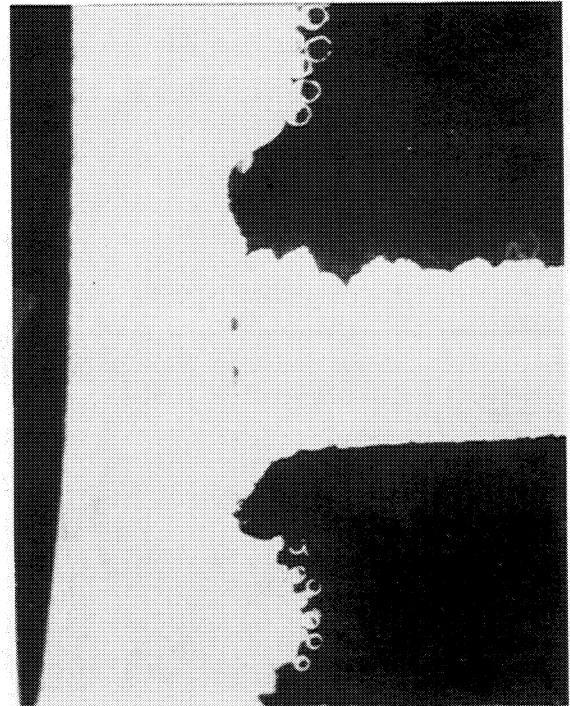
MARGINAL (?) ~ 10% DEFECTIVE

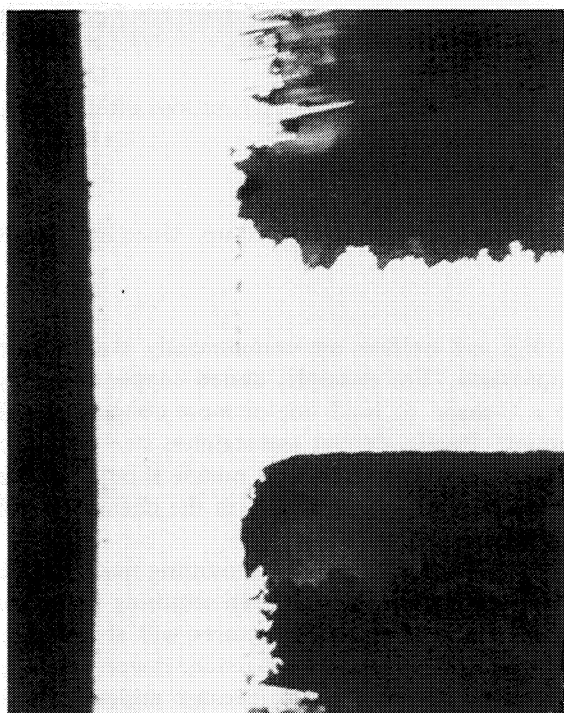
MODERATELY SEVERE: 10 – 50% DEFECTIVE

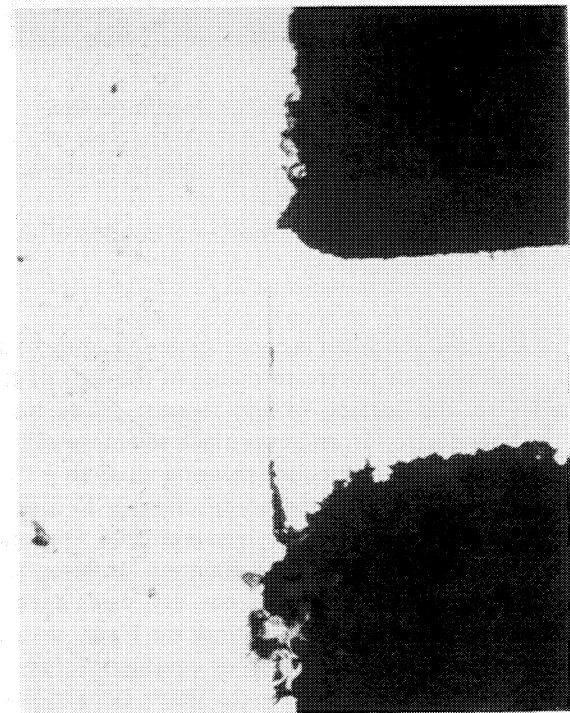
SEVERE: > 50% DEFECTIVE

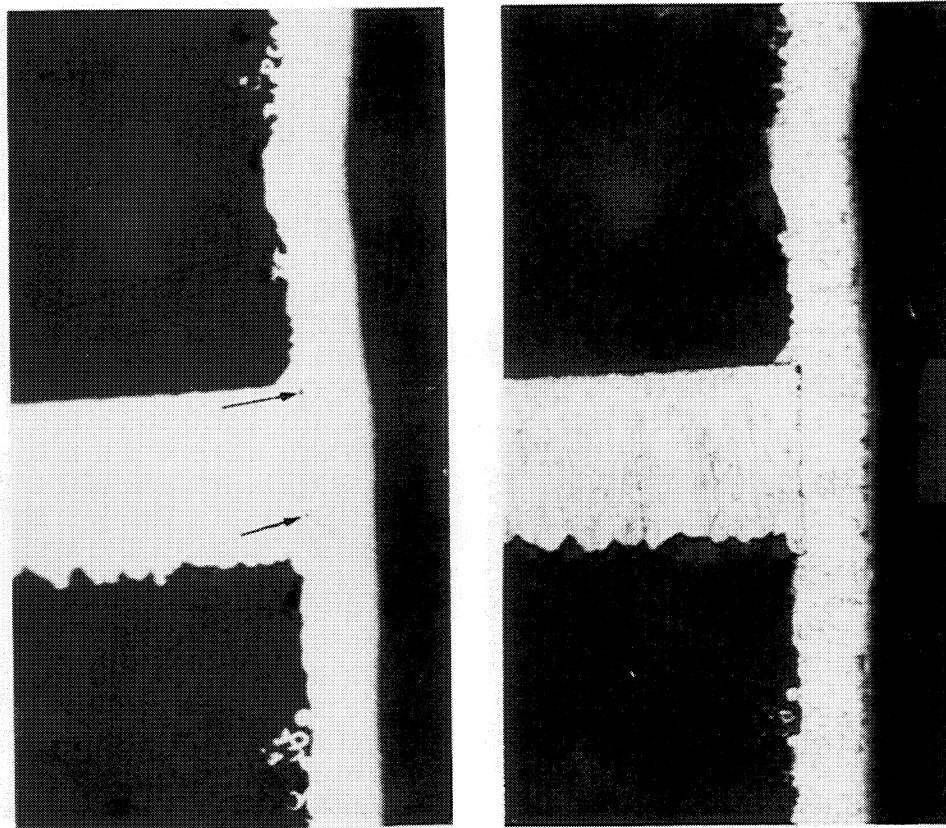
Figure 37. Minor point defects at barrel/innerplane junction visible in unetched condition would probably not be noticed in etched condition. These isolated small spots are not so worrisome as linear defects, and this hole could be accepted if other criteria are met. Left — unetched, 200X. Right — etched, 200X.

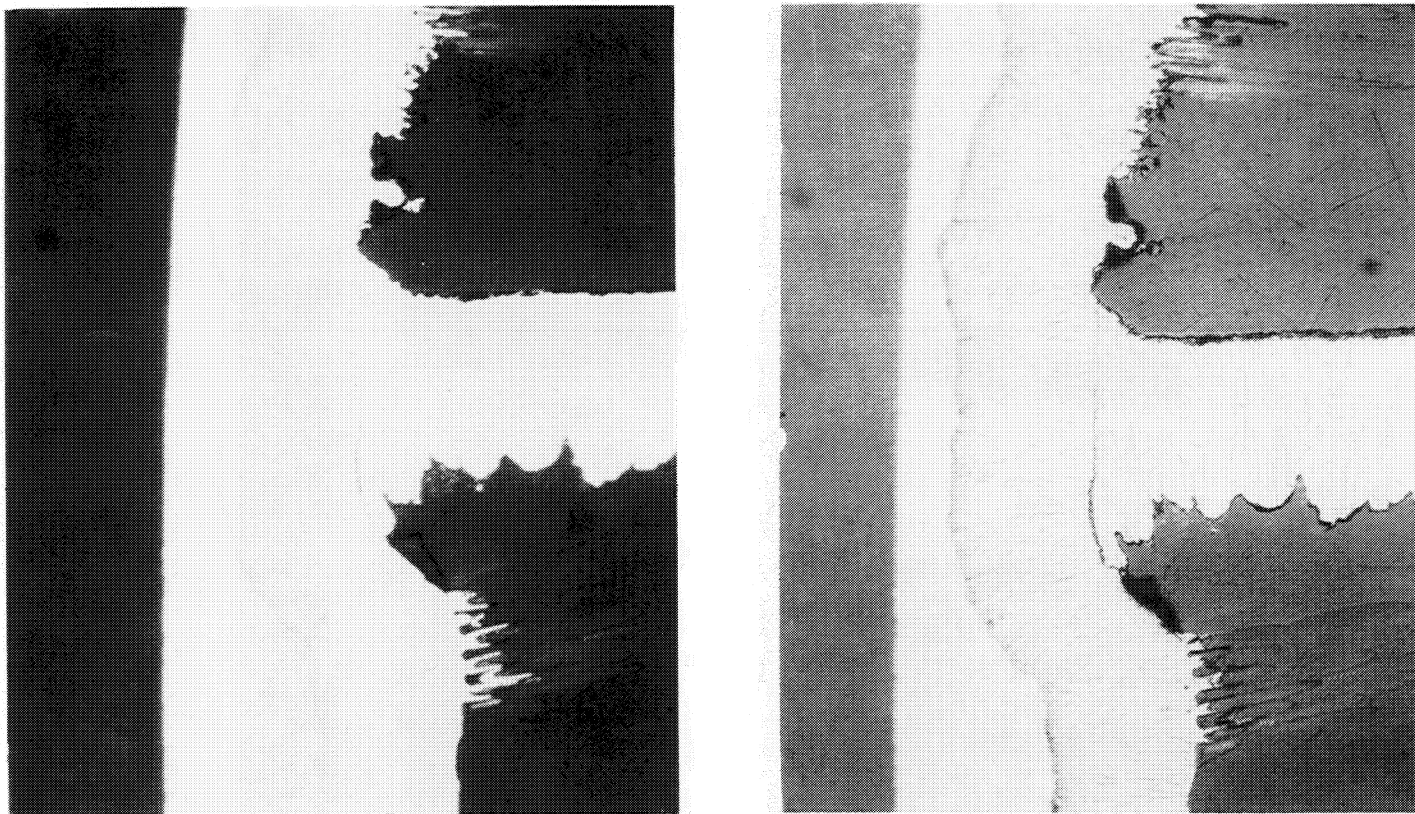
Figure 38. Linear defect extending more than halfway across junction is at least partly masked by etching. Note also the undesirable columnar plating microstructure. This hole should be rejected. Left — unetched, 400X; Right — etched, 400X.
